TR-03-2002

Resistance of Exterior Walls to High Velocity Projectiles

TECHNICAL REPORT
February, 2002

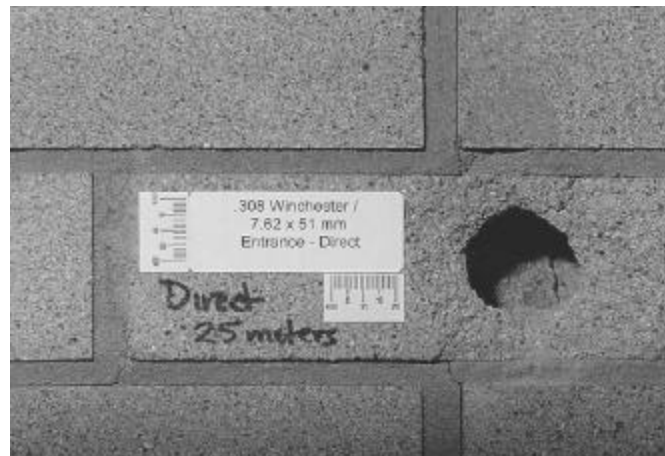
Figure 3 - Damage to clay brick caused by .308 Winchester

The .308 Winchester bullet produced a chip approximate 80 mm wide by 55 mm high from the brick. In addition, a 35 mm diameter hole was produced to a depth of about two thirds the brick thickness. The mortar was cracked around the perimeter of the brick. Figure 3 shows the damage caused by the .308 bullet.

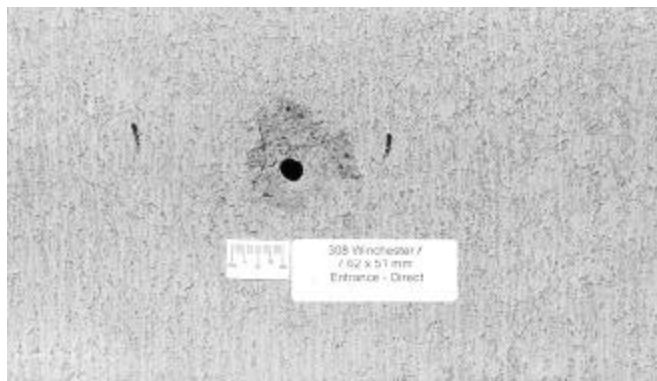
Figure 6 - Damage to the 140 mm concrete block wall caused by .308 Winchester

The .308 Winchester bullet penetrated both the front and rear face shells of the concrete block, passed completely through the foam insulation, and came to rest against the clay brick. It left a chip approximately 28 mm in diameter and hole approximately 10 mm in diameter. The entrance hole is shown in Figure 6.
